LAKE ROLAND DAM

NDI I.D. NO. MD 104

PHASE I INSPECTION REPORT

Lake John D. Dam. (NDI I.D. Number MD-104)
Chesapeake Bay Basin, Jones Falls, Baltimore
County, Maryland

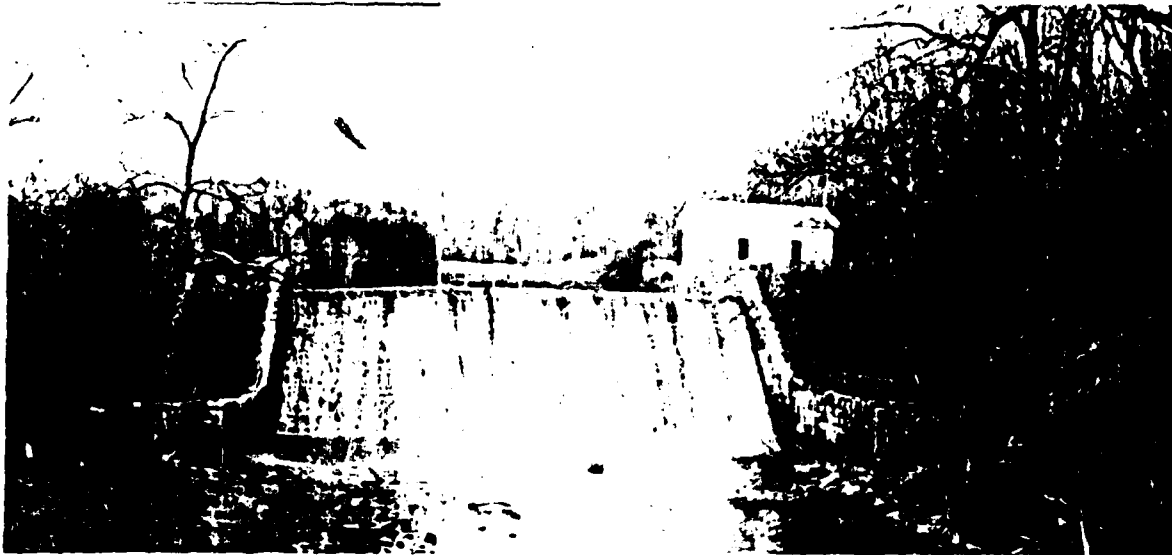
OVERVIEW OF DAM

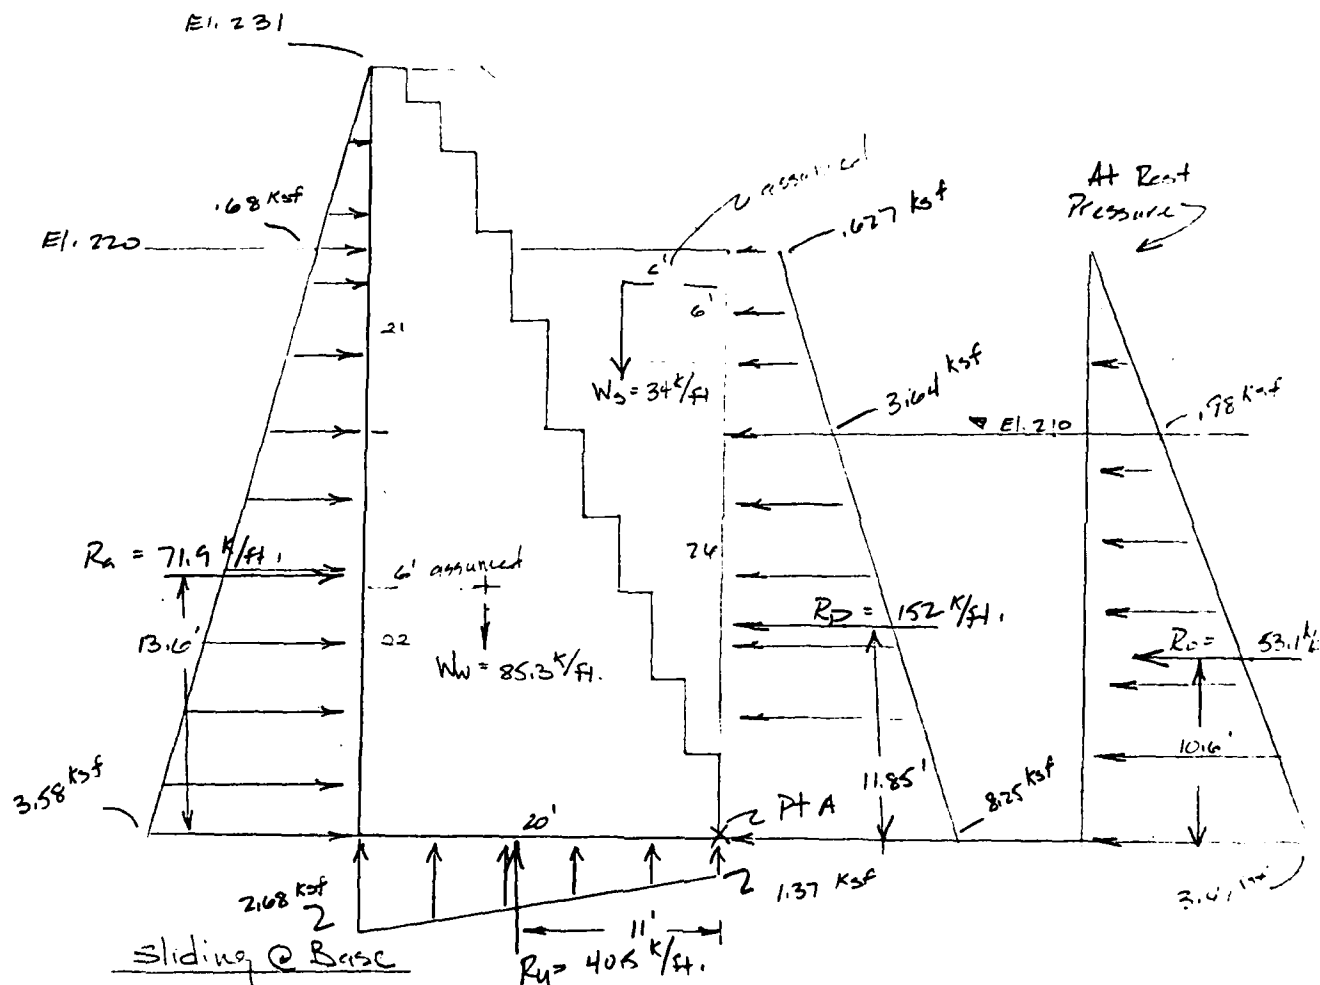
$$\begin{aligned} \text{Acting Force} &= 71.9 \text{ k/ft} \\ \text{Resisting Force (passive)} &= (85.3 + 34 - 40.5) \cdot 6.5 + 152 = 203.2 \text{ k/ft} \\ \text{Resisting Force (at rest)} &= (85.3 + 34 - 40.5) \cdot 6.5 + 53.1 = 104.3 \text{ k/ft} \end{aligned}$$

$$\text{F.S. passive} = \frac{203.2}{71.9} = 2.83 \quad \text{F.S. at rest} = \frac{104.3}{71.9} = 1.45$$

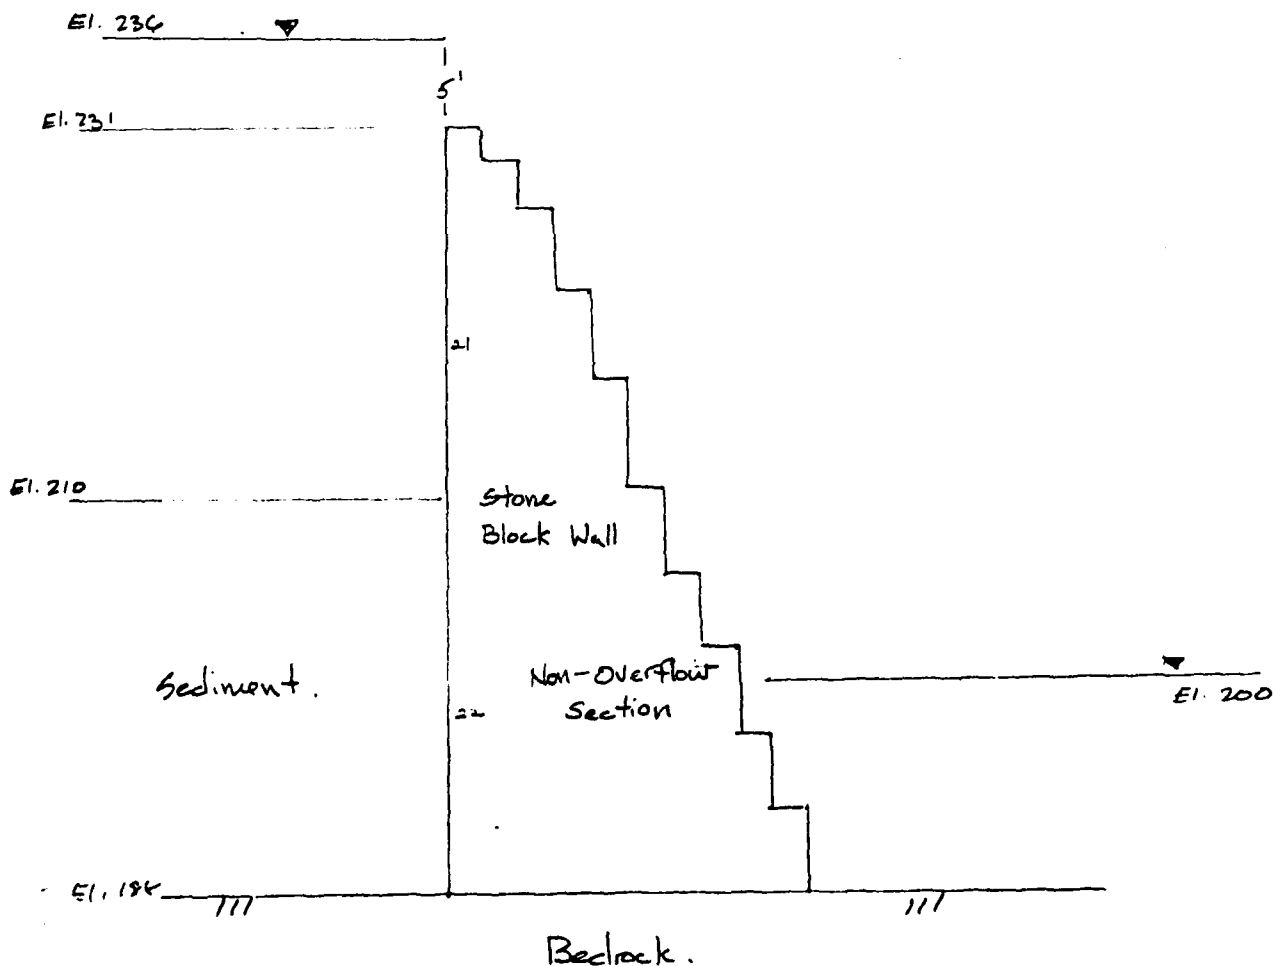
Analysis No. 3 Stability of Lake Roland Dam 5 ft. overtopping. Removal of soil cover downstream of stone block wall

5' of overtopping completely
erode soil backfill.

$\Sigma M_A \curvearrowleft = 85.3 \times 14 + 4.5 \times 4 = 1212 \text{ k/ft.}$

$F.S. = \frac{1212}{1615} = 0.75$
